Technical Bulletin

No: TDL-0086-B
Page 1 of 8

Issue New Hub and Seal.

Description: Herrin/Atlantis Platform Triple Lip Seal and Bearing Kit

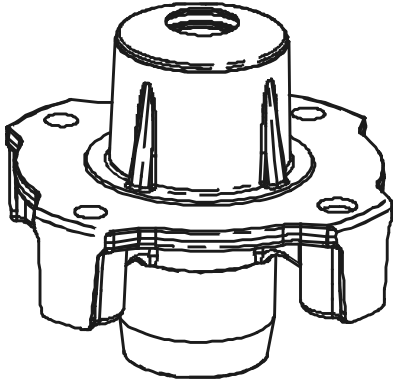
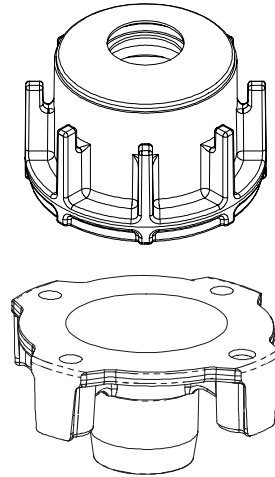
Sept 2005 production introduced a one piece integral hub/with seal assembly. The 21001868 seal kit that was used on prior models has also been modified with the new hub.

The new Integral Hub with Seal will update washer to current production parts.

Refer to the parts catalog for ordering the correct replacement parts.

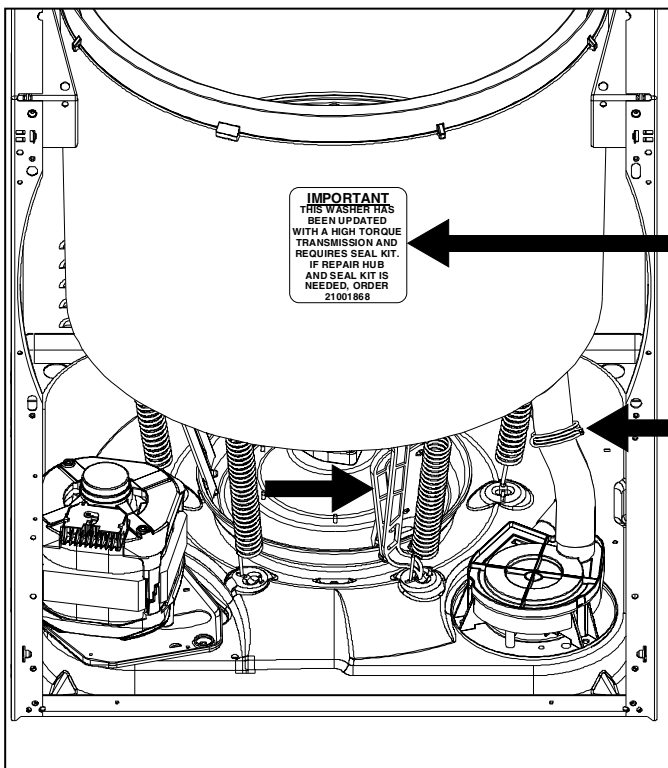
Note: Sticker indicating this machine has been modified with a “High Torque” service transmission and Seal kit 2101868. Placement of sticker is necessary when converting from the old transmission to the new “High Torque” transmission.

10. Remove Tub Springs with Spring Removal Tool (22002922).
11. Slide Drain Hose Clamp down and remove hose from washtub. Remove Pressure Hose from fitting on Outer Tub.
12. If this washer is being modified with a “High Torque Transmission” and “Triple Lip Seal”, place sticker in location shown. Only use this sticker if washer is being modified with a “High Torque” transmission and “Triple Lip Seal”.
