Service Bulletin

REFRIGERATORS
ARCTICA SIDE-BY-SIDE MODELS
BLUE CONNECTOR TEST

REF 05-03

MARCH 2003

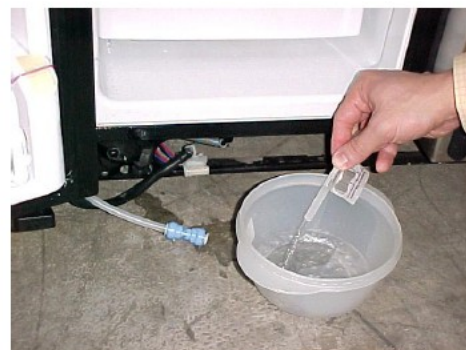
4. Disconnect tubing at the quick connect on the right hand side of the blue connector.

Note: The Blue Connector can be removed by simultaneously pushing the white collar inwards while pulling the tube outwards.

5. Place a container under the right side of the tubing to catch any water. Tape the light switch down to turn off the freezer light. Activate the water dispenser.

If water comes out of the tube the frozen freezer door must be replaced. **If water does not come out of the tube** do not replace the freezer door, instead see other resources for issues concerning no water dispensing or intermittent water dispensing.
