## Service Bulletin

Model #: ER48D/ER36D/ER30D

Product Description: ERC CONTROLLER UPGRADE / HEAT MAINTENANCE

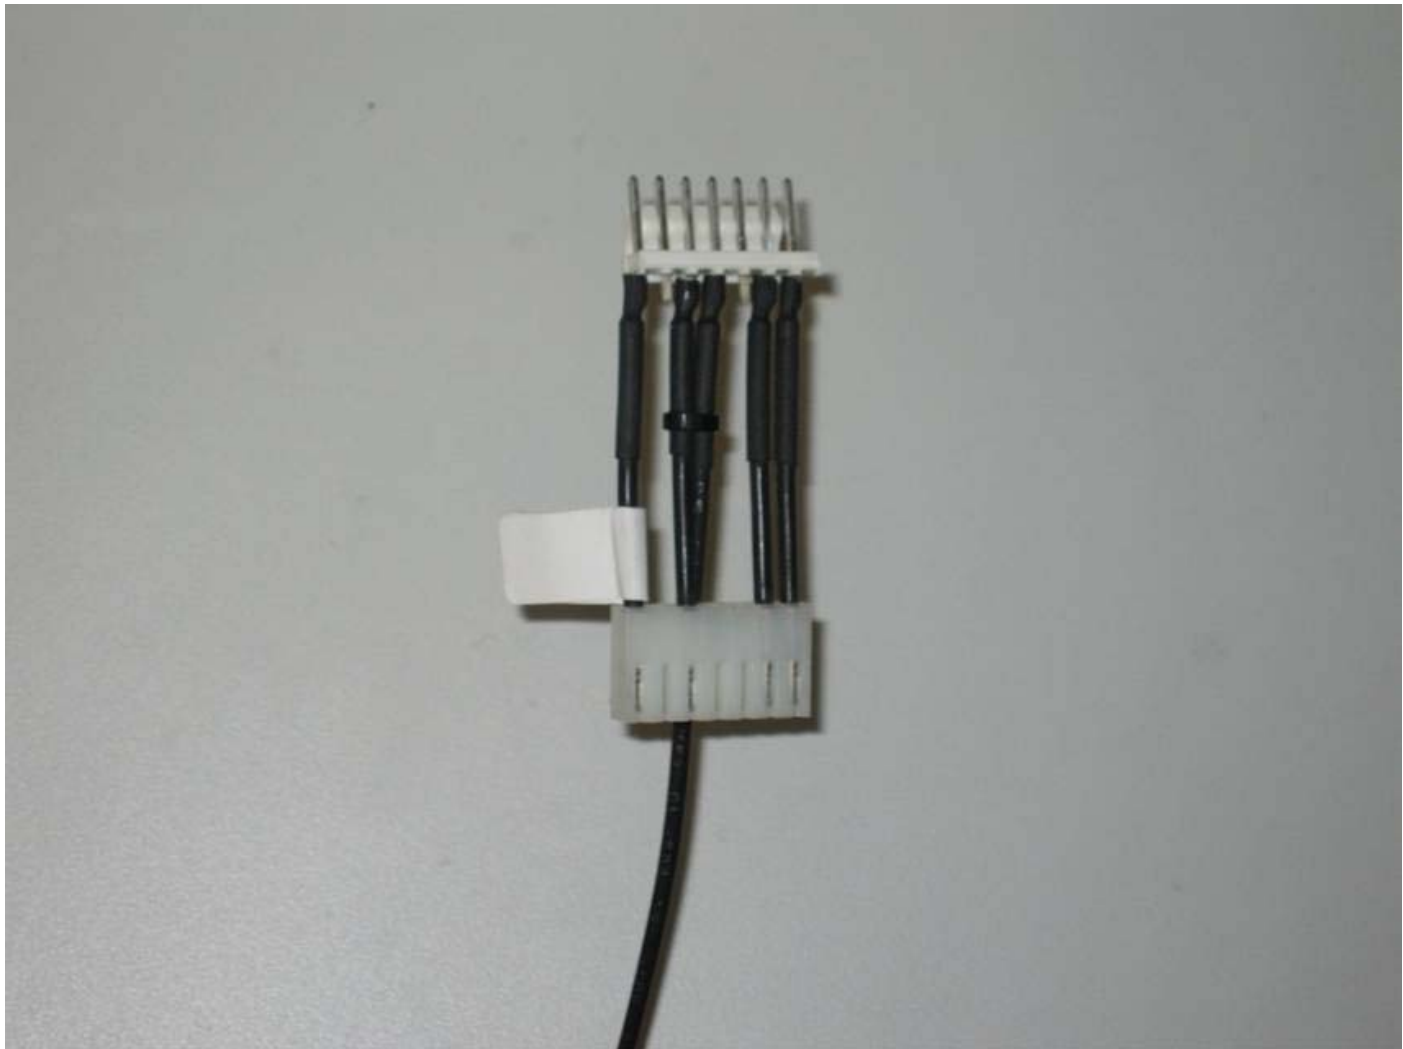
**Note: The DACOR CE/CF ADAPTOR HARNESS WAS NOT USED ON ALL UNITS. IF THERE IS NOT A HARNESS THE NEW CONTOLLER REPLACMENT IS A STRAIGHT CHANGE OUT THE PICTURE BELOW SHOW THE " DACOR CE/CF ADAPTOR" THAT NEEDS TO BE REMOVED AND DISCARDED.**

8. Remove the relay access cover between the center burner bases.
9. Unplug connector of the relay board at P33 and remove the DACOR CE/CF ADAPTOR HARNESS and reconnect original harness back onto P33. Remove the orange wire and black from the quick connector at P4 on relay board. Pull the orange wire off the black dual quick connection and reconnect the orange wire to the relay board at P4 discard the black quick connection.
