Technical Bulletin

No: TDL-0086-B
Page 1 of 8

Issue New Hub and Seal.

Description: Herrin/Atlantis Platform Triple Lip Seal and Bearing Kit

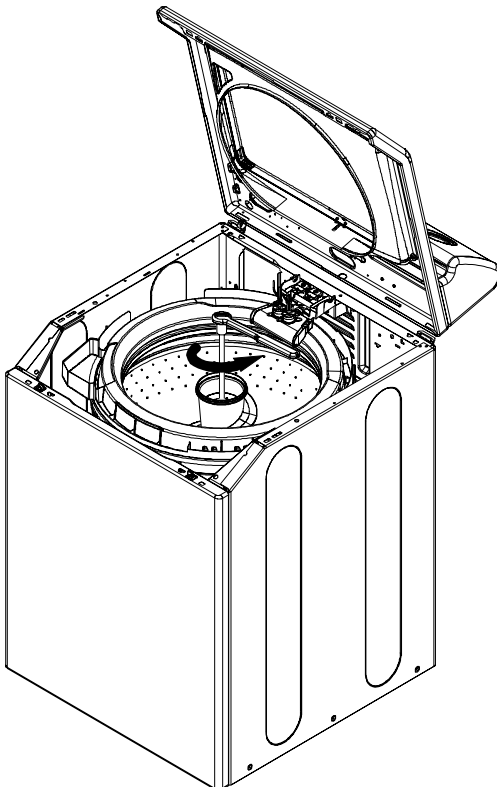
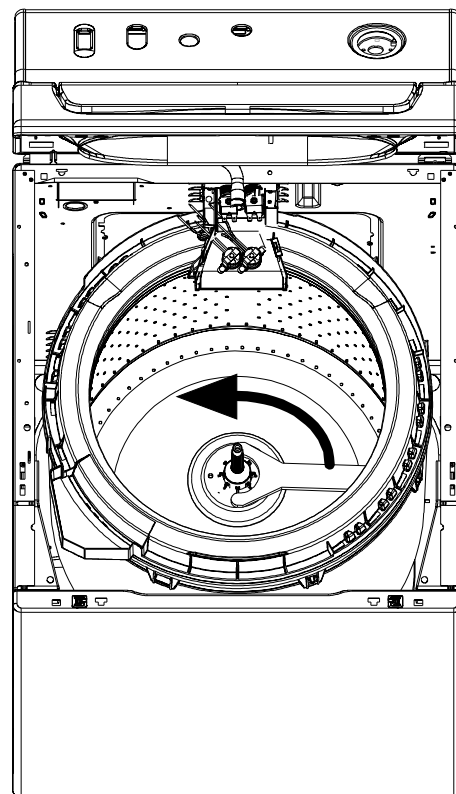
NOTE: September 2005 production, introduced a one piece integral hub/ with seal. Units built prior had a separate hub and seal nut.

4. Remove Agitator by loosening bolt threaded into Transmission Output Shaft, located inside agitator opening.
5. Use Spanner Wrench (35-2968) and Seal Tool (22002898) to remove Seal Nut if present.
