# DWTT2512

## Spray Arm Deformed

**BRAND:**
**Frigidaire**
**MODEL:**
**FDPH4316AS FDPC4314AS GDPH4515AF GDPP4517AD GDPP4517AF FDPC4221AB  
FDPC4221AS FDPC4221AW GDPH4515AF FFCD2418UB FFCD2418US FFCD2418UW  
FFID2426TD FFID2426TS LFID2426TF FGIP2468UF FDPH431LAF FFCD2413UB  
FFCD2413US FFCD2413UW FGID2466QB FGID2466QF FGID2466QW FGID2468UD  
FGID2468UF LFID2422RF FFID2423RS FGBD2434PB FGBD2434PF FGBD2434PW  
FFBD2406NB FFBD2406NS FFBD2406NW FFBD2408NB  
FFBD2408NM FFBD2408NS FFBD2408NW FGBD2438PF  
FGBD2438PW FGBD2438PB LFBD2409LF**
**SERIAL:**
**All**

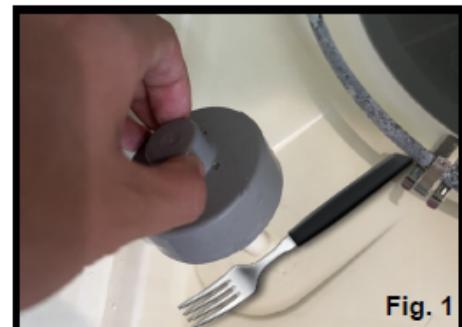
**Fig. 1**

**CONDITION:**
**Melted spray arm, deformed heater, and/or tub damage.**
**SOLUTION:**
**Please verify the following:**

- 1.) Confirm Round Heater (PN: 154825001) operation.
  - a. Should generate 7A to 9A while energized.
  - b. With the unit unplugged confirm resistance (10 to 20 ohms).
  - c. Check both sides to ground (should be OL).
- 2.) Enter diagnostics test mode. (see Tech Data Sheet)
- 3.) Confirm the unit is filling with water as designed.
  - a. If not filling, confirm water supply is turned on.
  - b. Inspect for debris under the float causing the switch to close contacts. (Fig. 1)
  - c. Remove power from the unit and verify the switch has proper resistance. (Fig. 3)
- 4.) Reference the owners guide for proper loading techniques.
  - a. Utensils are properly positioned.
  - b. Pot & Pan handles are not going through racks to obstruct spray arms.
  - c. Verify plates are not preventing rotation of spray arms.
