Motor Assembly

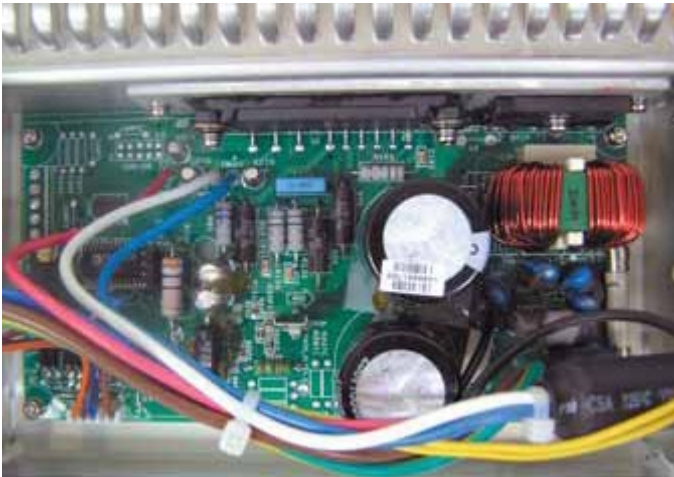
On the inverter board, check for an approximate resistance value of 6 ohms between any two of the three terminals:

A to B (Blue to white) – 6 Ω

A to C (Blue to red) – 6 Ω

B to C (White to red) – 6 Ω

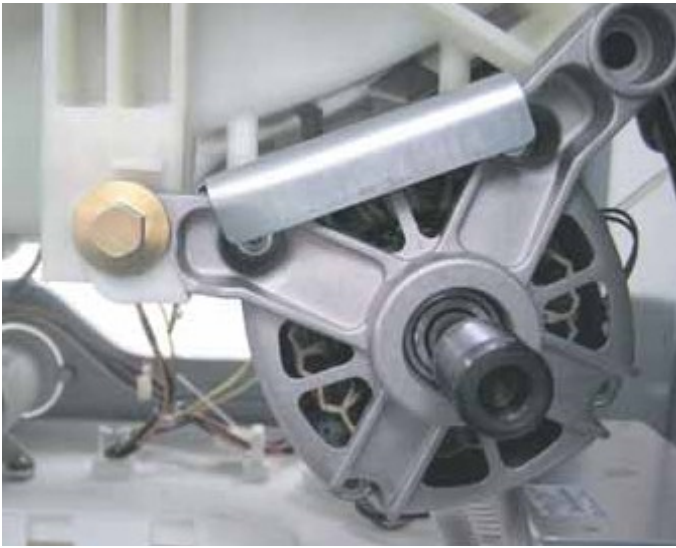
Remove the 1/2-in. bolt from the threaded plate that holds the motor arm to the outer tub.

Note: The threaded plate can fall out of the recessed slot in the motor mount. Ensure this plate is reinserted in the slot upon reassembly.

Note: When reinstalling bolt, apply Locktite (Part # WX5X1005) to bolt threads. Ensure motor arm is at lowest position under motor bolt before tightening.

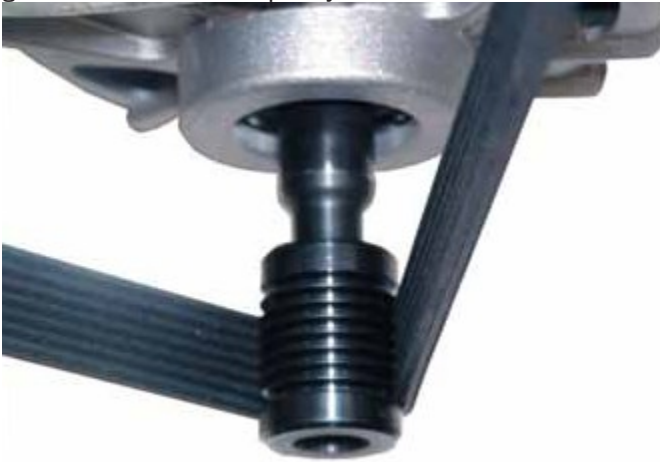
Note: When reinstalling the belt, ensure the belt is positioned to track in the 7 outer grooves of the motor pulley.
