Service Bulletin

HL02-10

MODELS: DLSR483EG/GG, DWSR483EG/GG,
DWXR483EG/GG, DBSR463EG/GG,
DBXR463EG/GG, DJXR433EG/GG

Customer Issue

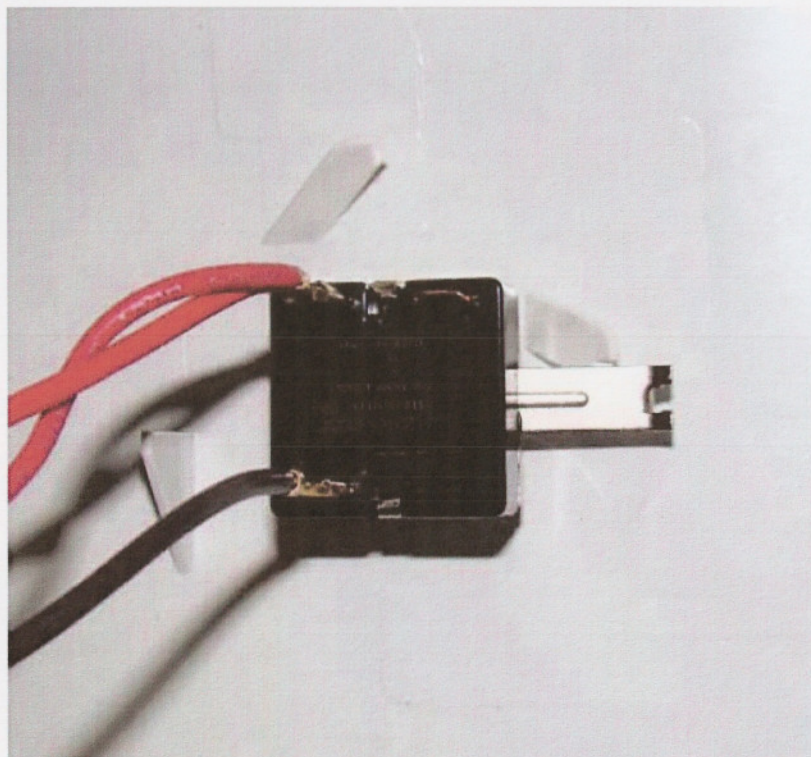
Rotary start switch is loose or has fallen off control panel on models produced between January and May 2010 (serial numbers AT - HT).

Start switch and control panel example

When replacing the control panel due to a broken switch mounting tab on models produced between January and May 2010, DO NOT reinstall the old switch on the new control panel. You **MUST** replace the start switch at the same time as the control panel or the issue may reoccur.
